# Manhole Inspection Summary

Manhole # S29UU1022MH

Insp Date: **1/10/07 2:34 PM**

**Location** Address: **308 WYNDHURST AVE**

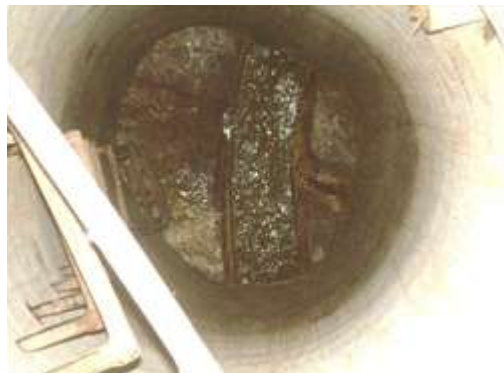
Top View

Bench debris.

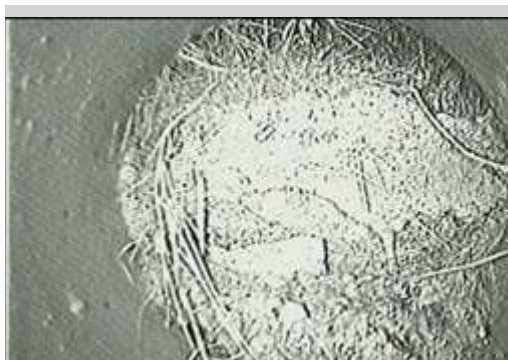
Inside the I4

Plugged/Roots

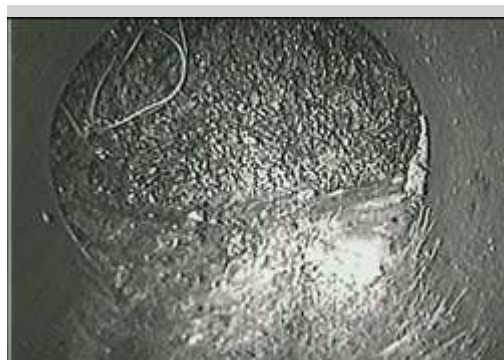
Inside the I9

Plugged/Roots. Inflow

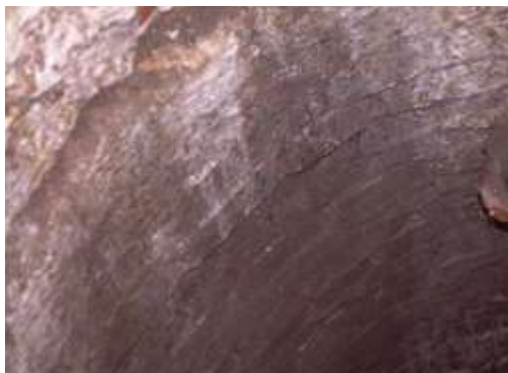
Defect

**Chimney / Frame Adjustment** ☒ Exists Material: **Brick** ☐ Parged Height: **9** (in.)

Infiltration: ☐ None ☒ **Joint** ☐ Cracks ☒ **Mortar** ☐ Roots ☐ Wall

Adjustment infiltration.

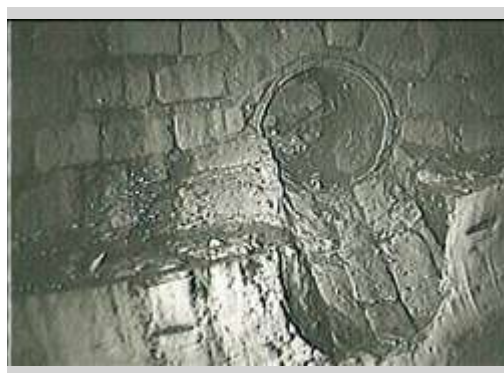
Defect

Condition: ☐ Sound ☐ Cracked ☐ Root Intrusion ☐ Loose Brick ☒ **Deteriorated**

Infiltration: ☐ None ☐ Joint ☐ Cracks ☒ **Mortar** ☐ Roots ☒ **Wall**

Barrel deterioration and infiltration.

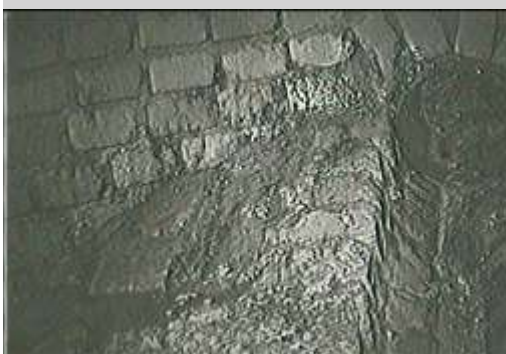
Defect

Barrel infiltration.

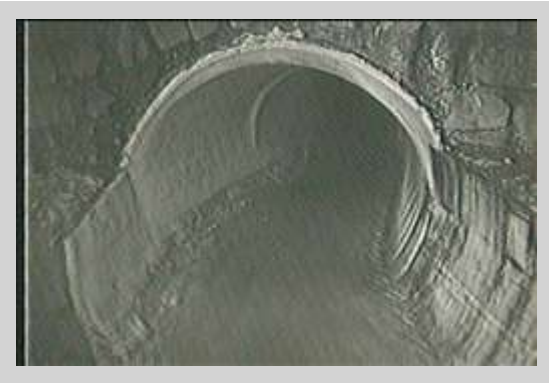
### 18 in. Circular Gravity Sewer Pipe Out @ 12 O'Clock

Barrel deterioration and infiltration.

Infiltration: **Evidence** Pipe Seal Cond: **Cracked**

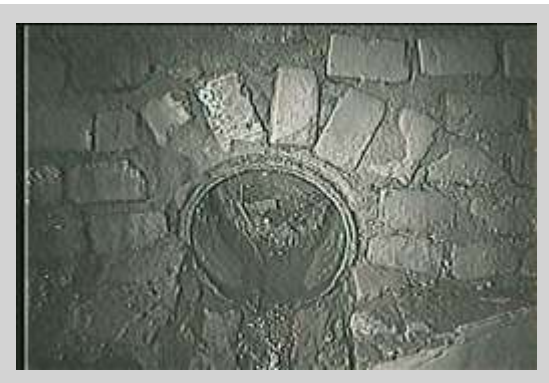
### 8 in. Circular Gravity Sewer Pipe In @ 4 O'Clock

Channel deterioration. Plugged - Inflow.

Infiltration: **Weeper** Pipe Seal Cond: **Unknown**

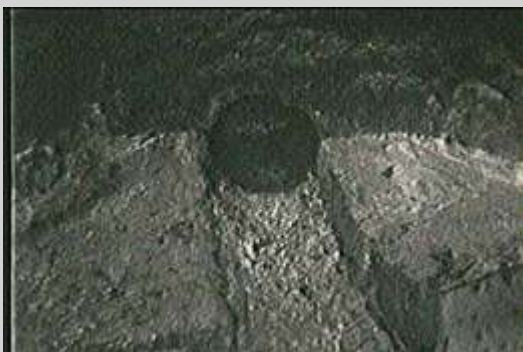
Pipe In @ 9 O'Clock

Infiltration: **Weeper** Pipe Seal Cond: **Unknown**
